**STUDY SUMMARY – WHITE PAPER**

**January 12, 2023**

**Snouffer School Road High Injury Network Safety Study  
Recommendations Specific to Montgomery County DOT**

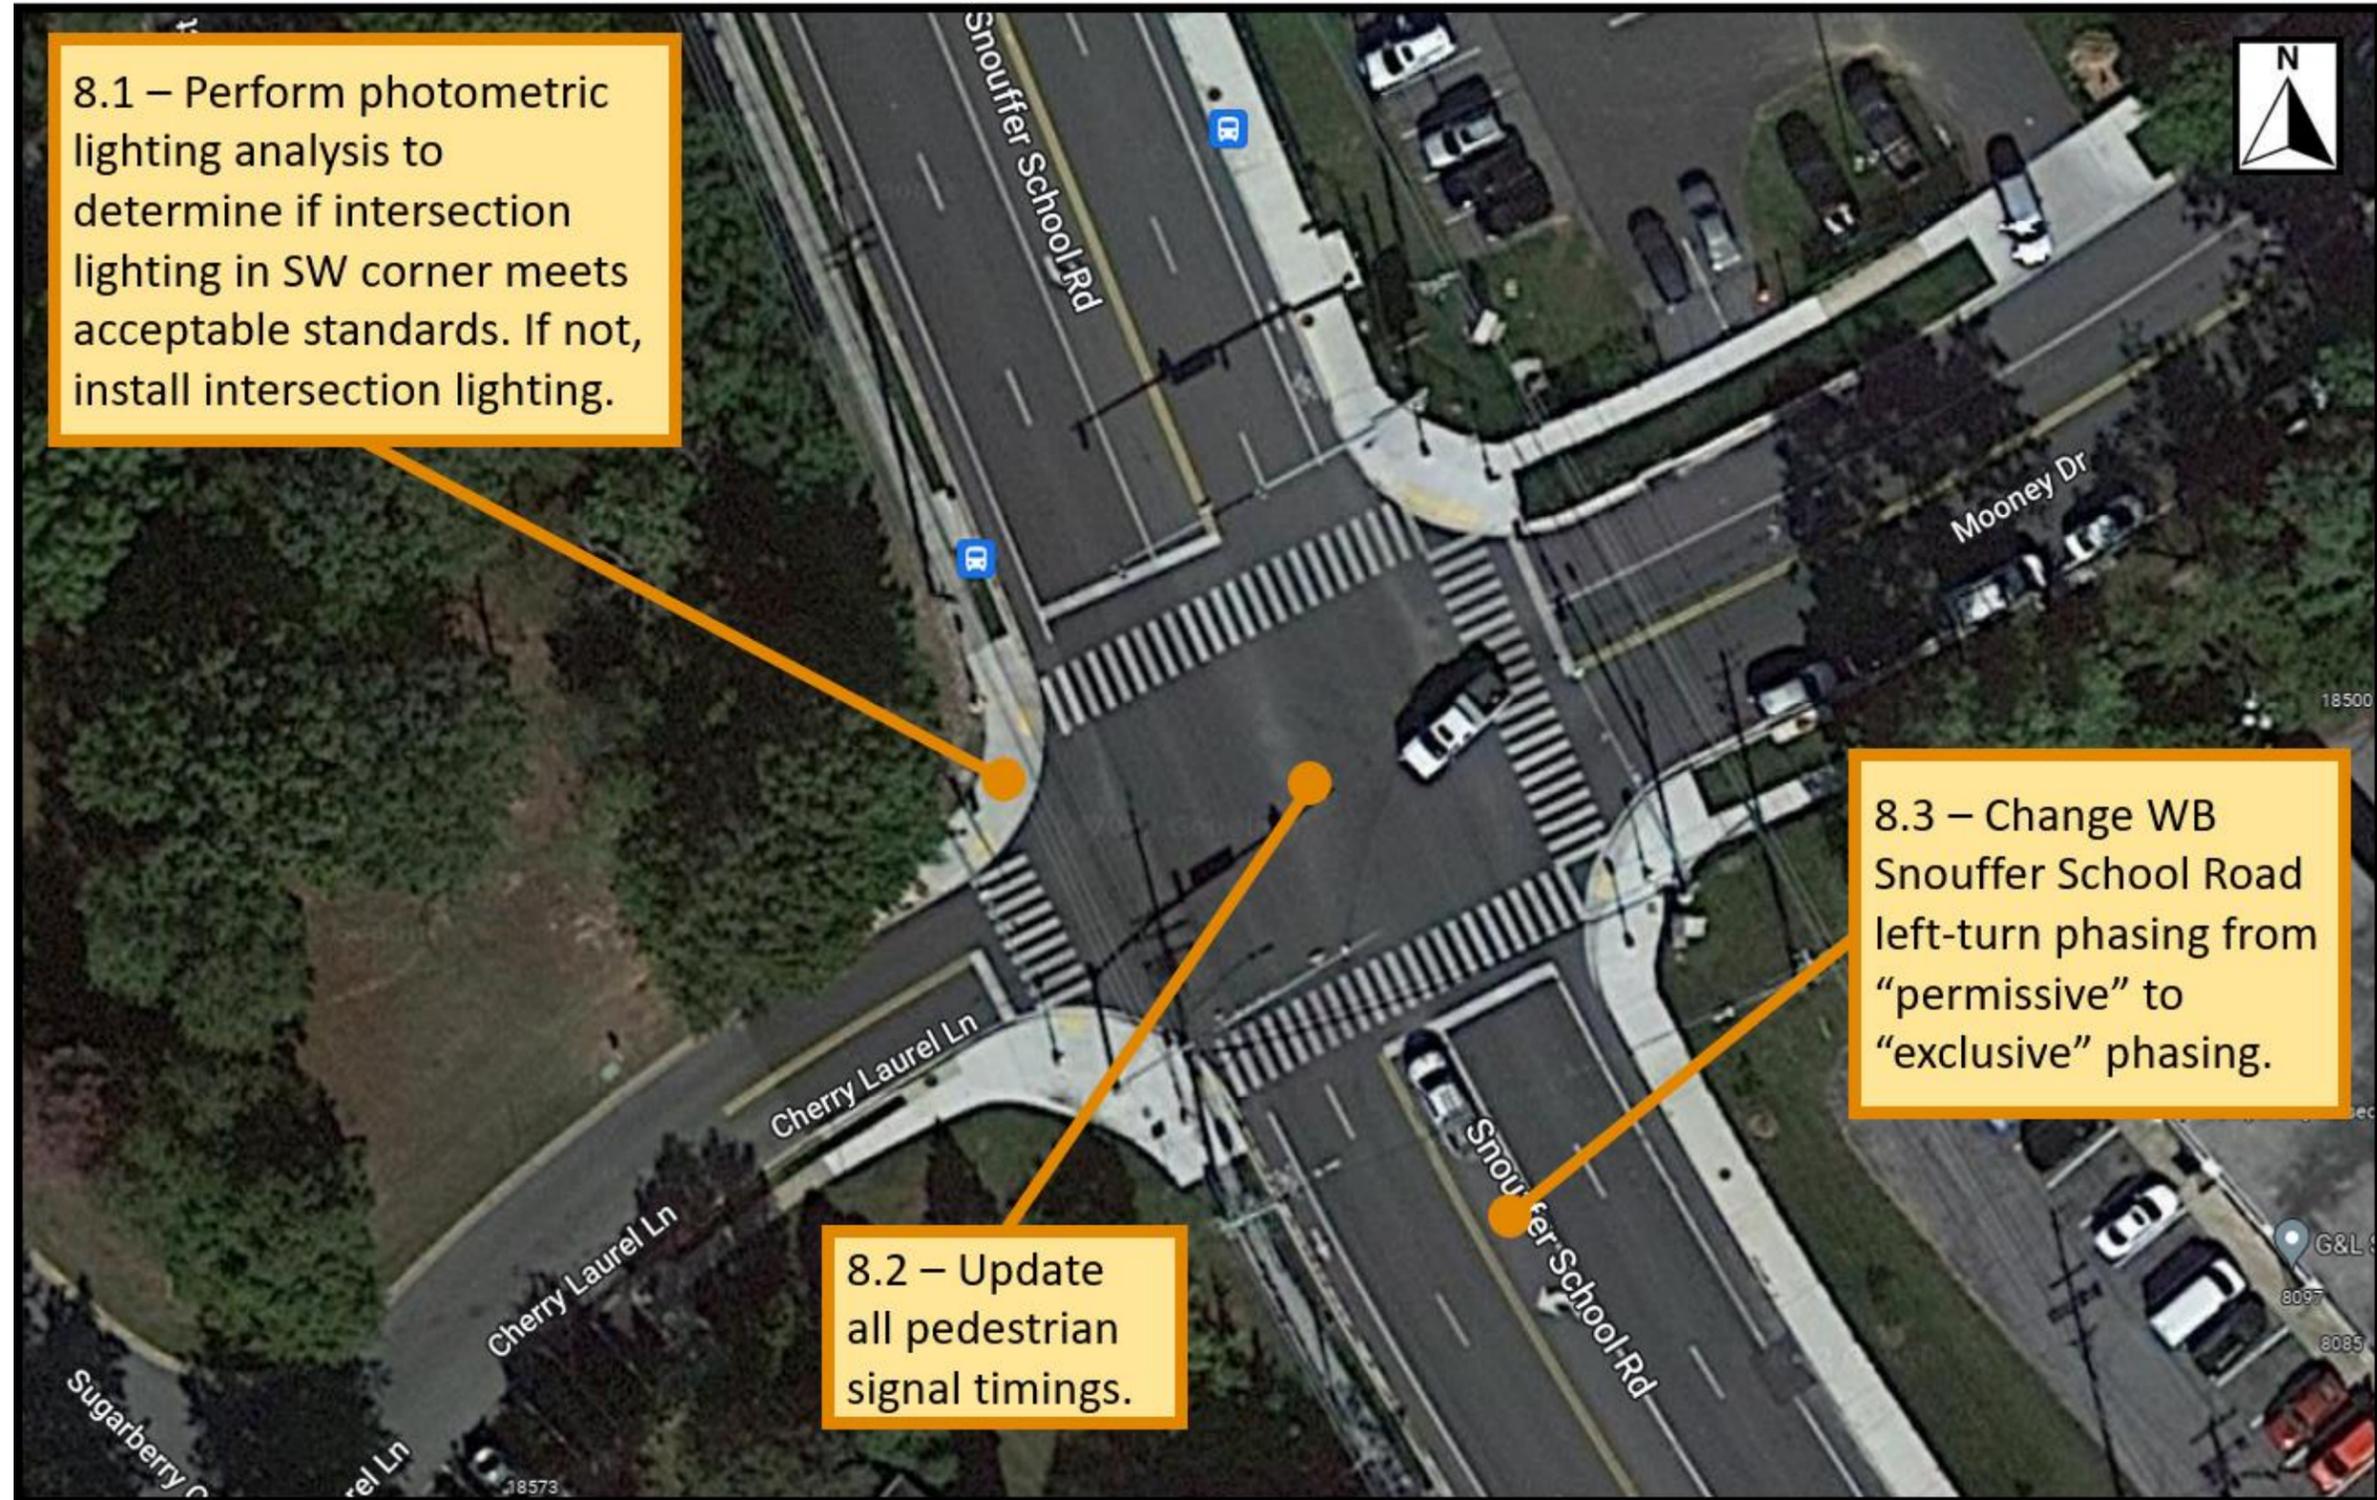
Figure 8: MCDOT – Specific Recommendations: Snouffer School Road at Cherry Laurel Lane/Mooney Drive

8.1	There are no intersection lights present in the SW corner of the intersection.	Perform a photometric lighting analysis to determine if intersection lighting in the SW corner of the intersection meets acceptable standards. If not, install intersection lighting in the SW corner of the intersection to meet acceptable standards.	12+ months

8.2	Flashing Don't Walk times are insufficient - 12s for crossing Cherry Laurel Lane/Mooney Drive; 16s for crossing Snouffer School Road.	Update pedestrian signal timings to ensure pedestrian clearance intervals are adequate.	0 – 6 months

8.3	The WB Snouffer School Road left turn sight distance at Cherry Laurel Lane is limited when there is a vehicle queued in the opposing EB Snouffer School Road left turn lane.	Change the WB Snouffer School Road left-turn phasing from "permissive" to "exclusive" phasing.	0 – 12 months
Location 9: Snouffer School Road at Sweet Autumn Drive – Future Signalized Intersection

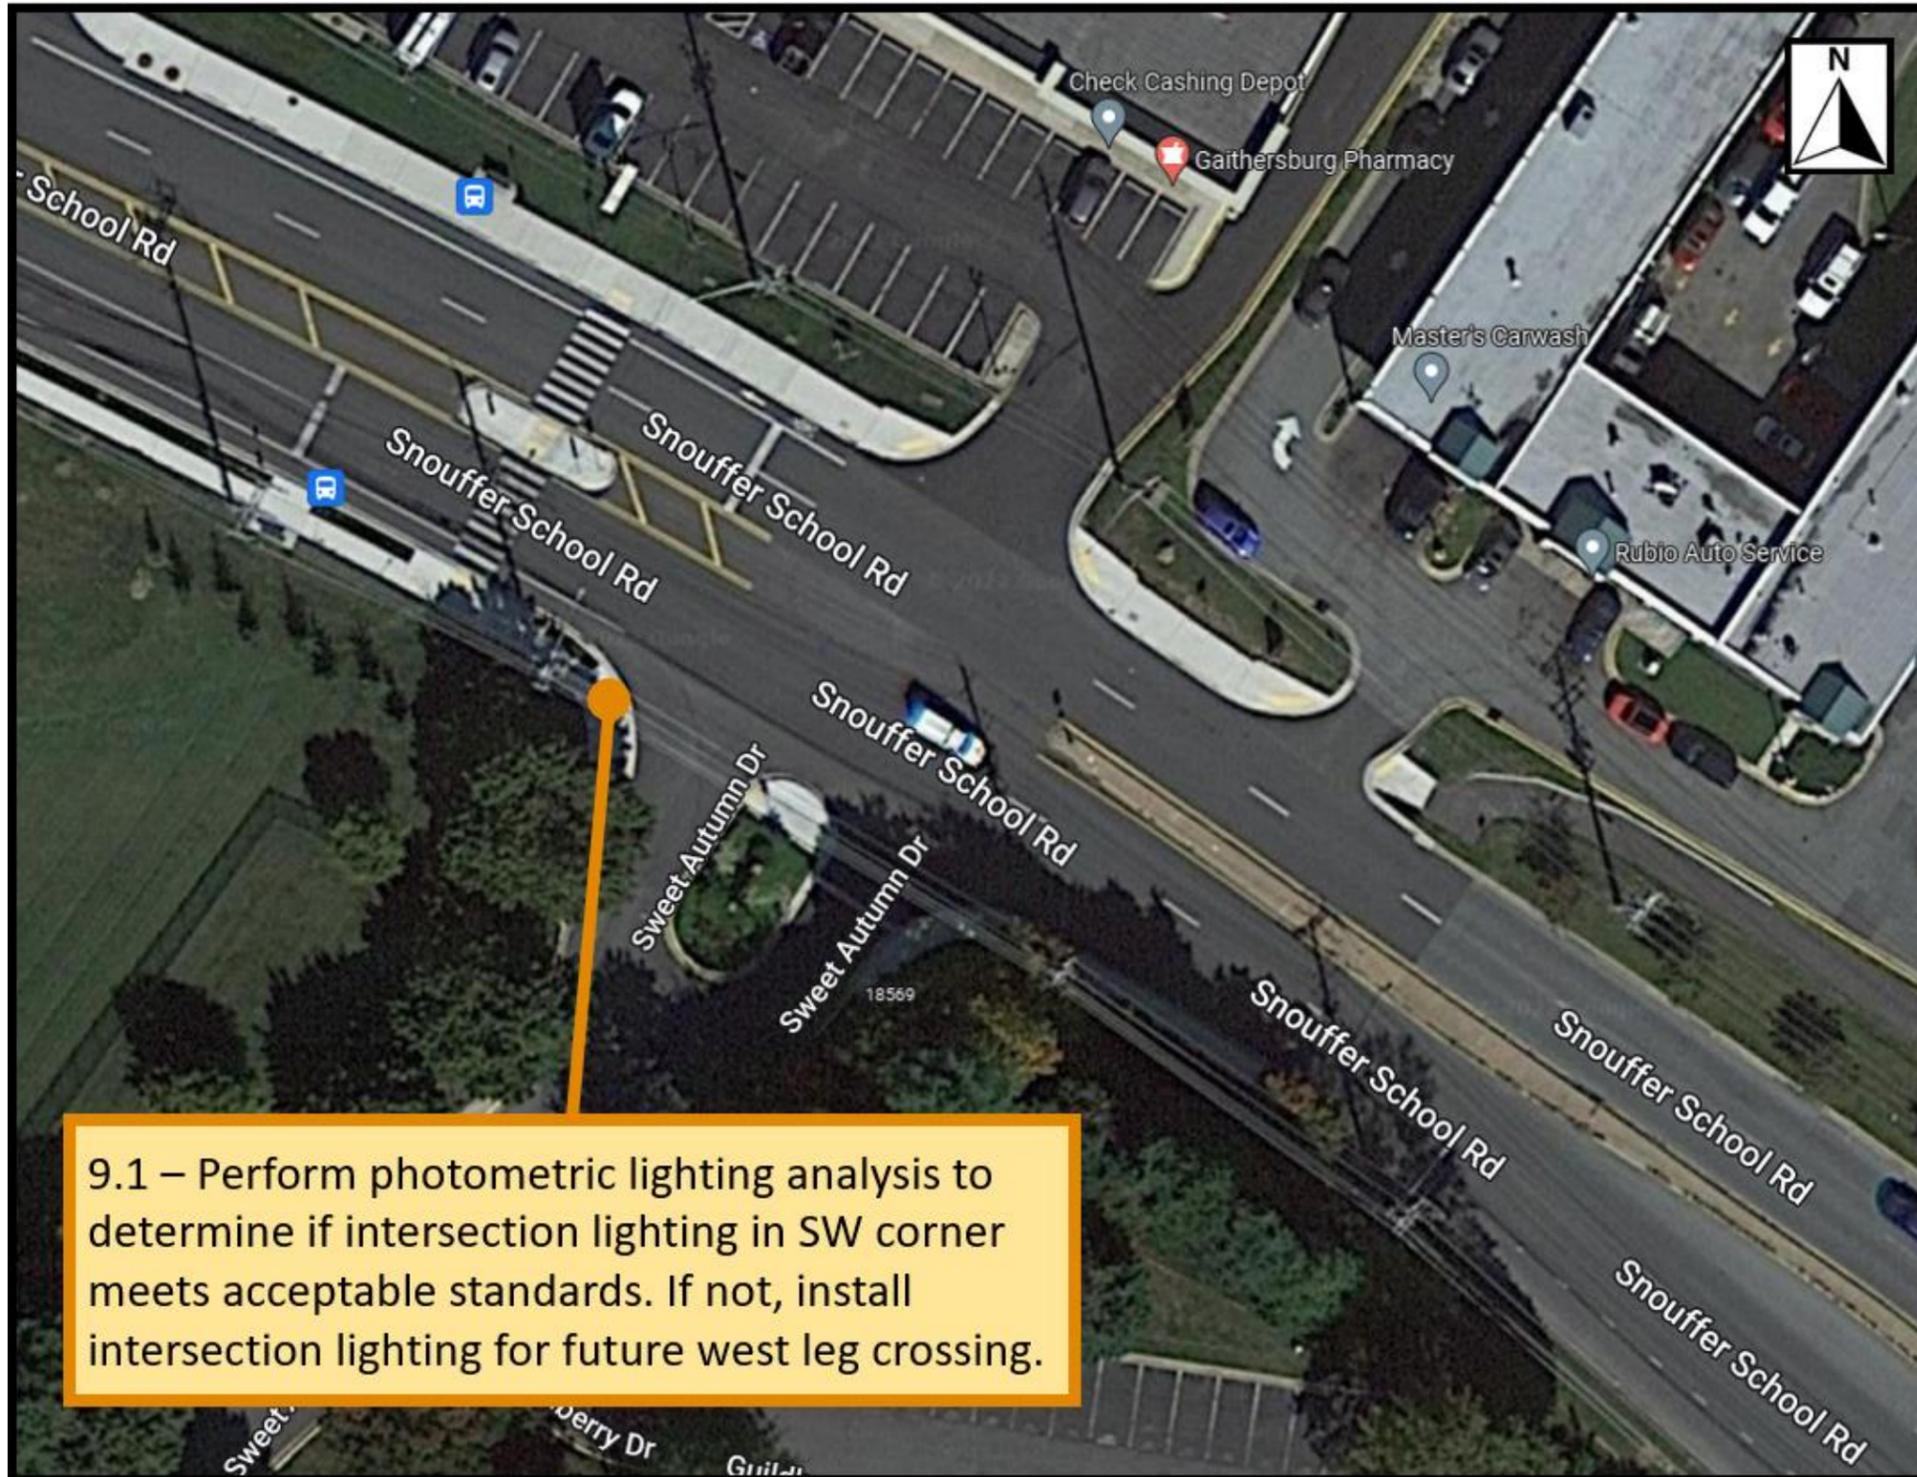
Figure 9: MCDOT – Specific Recommendations: Snouffer School Road at Sweet Autumn Drive

9.1	There are no streetlights present in the SW corner of the intersection (where a future marked crosswalk for the west leg of the Snouffer School Road/Sweet Autumn Drive signalized intersection will be located).	Perform a photometric lighting analysis to determine if intersection lighting in the SW corner of the intersection meets acceptable standards. If not, install intersection lighting in the SW corner of the intersection to ensure illumination of the future marked crosswalk for the west leg meets acceptable standards.	12+ months
Location 10: Snouffer School Road at MD 124 (Woodfield Road) – Signalized Intersection

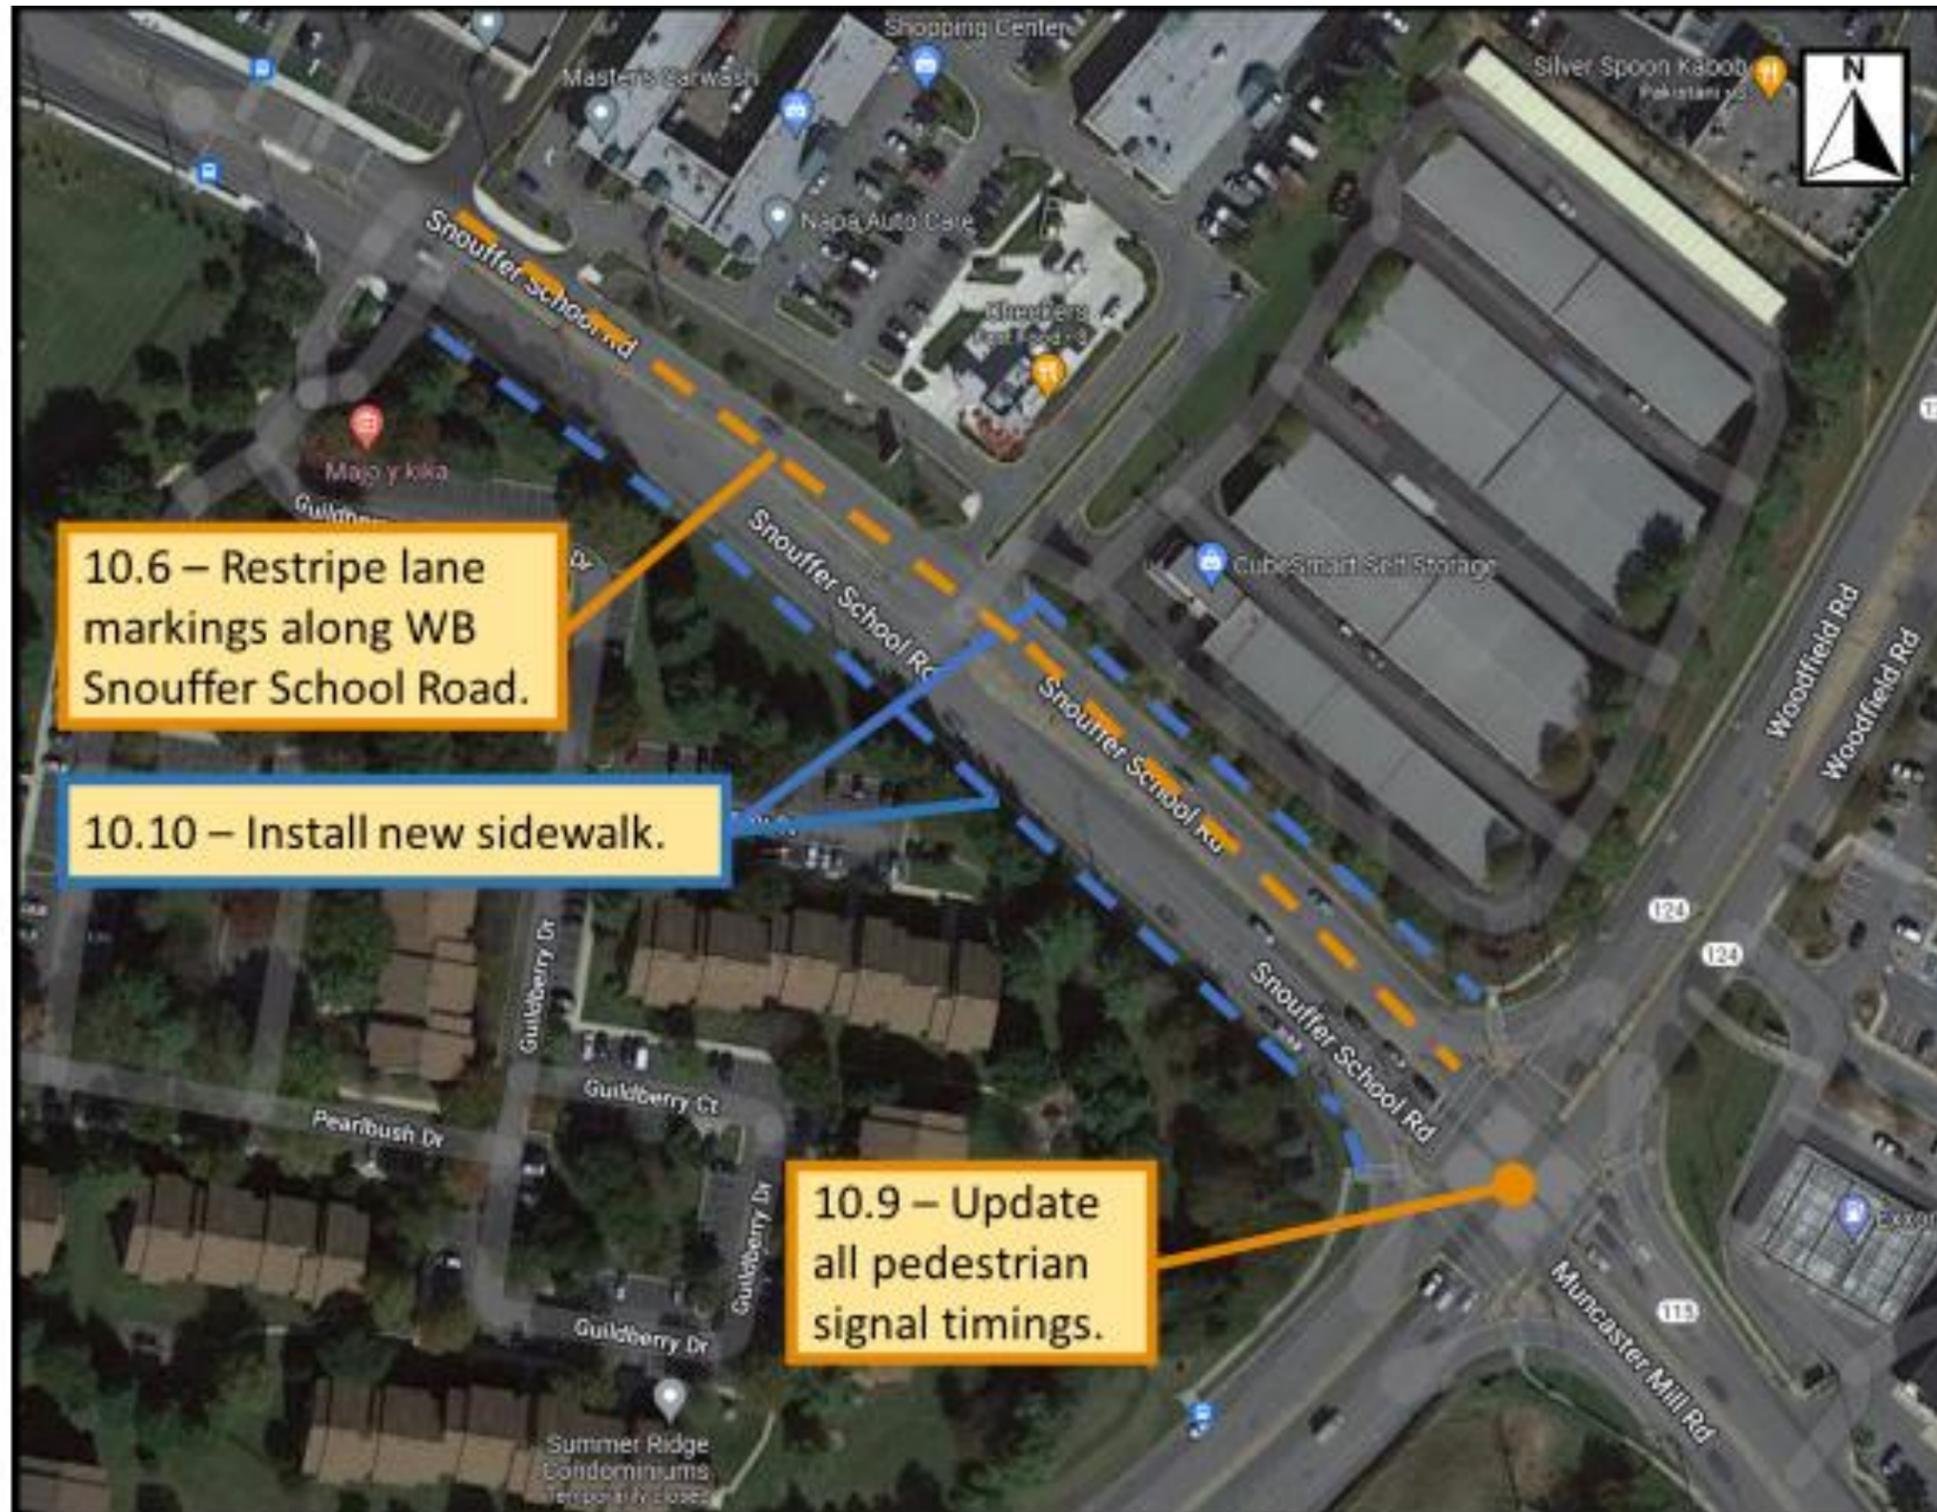
Figure 10: MCDOT – Specific Recommendations: Snouffer School Road at MD 124 (Woodfield Road)

10.6	Lane markings along WB Snouffer Road between MD 124 and the east driveway to the Horizon Center Shopping Center are fading or faded.	Restripe lane markings along WB Snouffer Road between MD 124 and the east driveway to the Horizon Center Shopping Center.	0 – 12 months

10.9	Pedestrian Clearance Interval is inadequate for crossing the north and south legs of MD 124.	Update pedestrian signal timings to ensure pedestrian clearance intervals are adequate.	0 – 6 months

10.10	There is no sidewalk along EB and WB Snouffer School Road between MD 124 and Sweet Autumn Drive.	Install new sidewalk along EB and WB Snouffer School Road to ensure a continuous connection between existing sidewalk at the MD 124 intersection, and the sidewalk/side path at/near Sweet Autumn Drive. Note that MCDOT is currently pursuing a sidewalk connection between these intersections.	6 – 12+ months
Location 11: Corridor-Wide
